Manhole Inspection Summary

Manhole # S02GG2013MH

Location Address: **6718 Westbrook Rd**

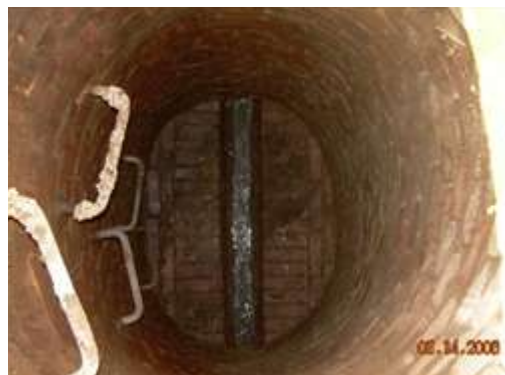
Top View

Condition: ☐ Sound ☒ **Cracked** ☐ Root Intrusion ☐ Loose Brick ☒ **Deteriorated**

Infiltration: ☐ None ☒ **Joint** ☐ Cracks ☐ Mortar ☐ Roots ☐ Wall

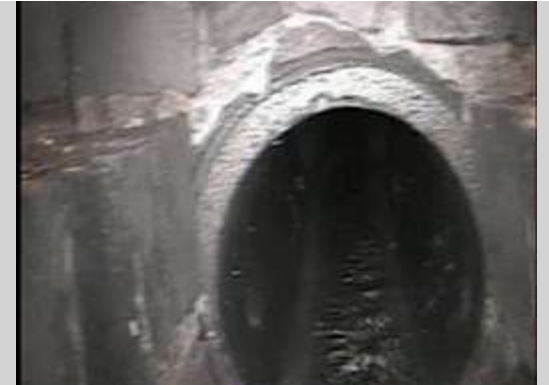
8 in. Circular Gravity Sewer Pipe Out @ 12 O'Clock

Pipe Material: **Clay** ☐ Pipe Lined

Invert Depth: **9.76** (ft.) Flow Characteristics: **Fast**

Infiltration: **None** Pipe Seal Cond: **Sound**

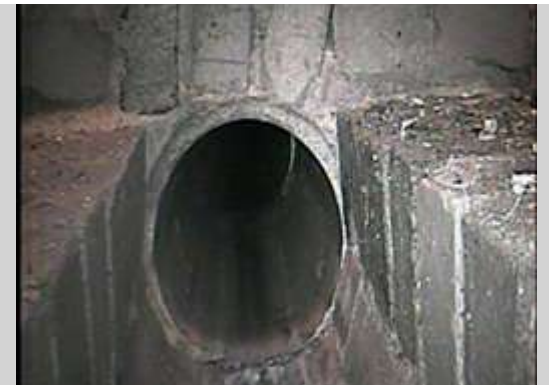
8 in. Circular Gravity Sewer Pipe In @ 6 O'Clock

Pipe Material: **Clay** ☐ Pipe Lined

Invert Depth: **9.71** (ft.) Flow Characteristics: **Fast**

Infiltration: **None** Pipe Seal Cond: **Sound**
